Gungadin Drive Erosion Mitigation

Concept Design Report

Prepared for:
Anderson Township, Ohio

Prepared by:
Stantec
Cincinnati, Ohio

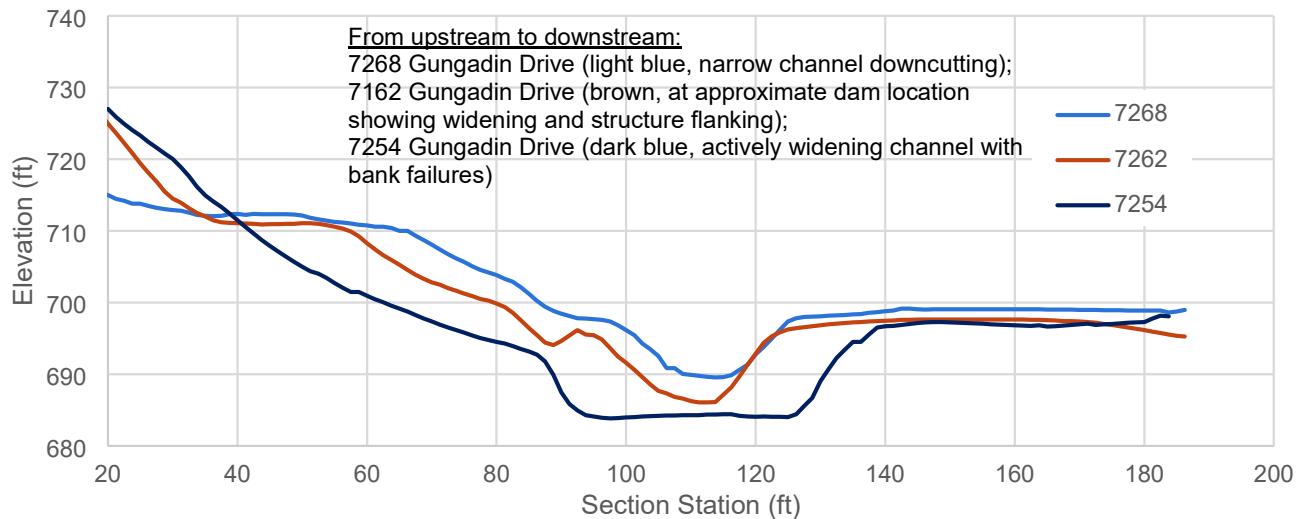
Figure 4. Channel sections cut from DEM data

The stream adjacent to Gungadin Drive is in a disequilibrium state, and erosion observed within the area of concern is the result of channel evolution towards a new steady state. Preliminary examination suggests it is in Stage III of the model shown in Figure 3, typified by channel widening and bank failures (Figure 4).

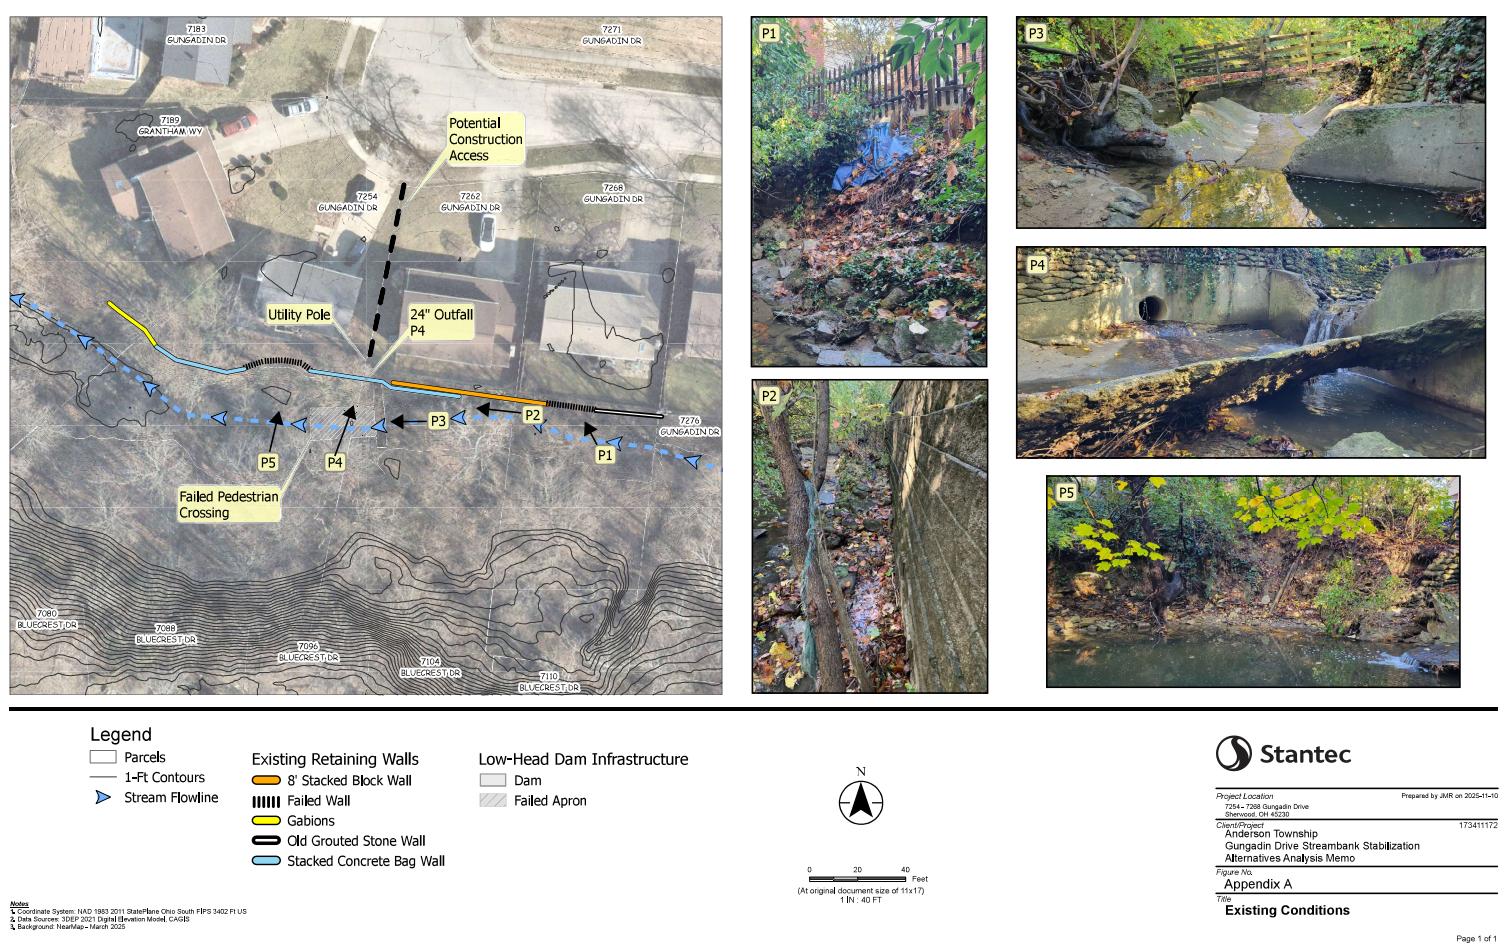
Figure No.
Appendix A

Appendix A provides an overview of the site visit and select photos. Erosion was observed on both banks of the stream, increasing in severity toward the west end of Gungadin Drive. The slope above the south bank was observed as steep, with several areas showing severe erosion and downed trees, apparently due to progressive slope degradation. Several retaining walls were observed along the north bank, including block, concrete bag, natural stone, and gabion baskets. These walls were in various states of condition, ranging from failed to good condition.

In the same location as the various retaining walls (approximately 7254 to 7268 Gungadin Drive), an existing notched low-head dam with a failed concrete apron were observed (Photo 3, Appendix A). The notched dam and failed concrete apron have led to the failure of a private pedestrian crossing, accelerated erosion of the south bank, and undermining of a retaining wall (Photo 5, Appendix A).

The second driver of instability is the low-head dam and failing concrete apron. The low-head dam was notched (Photo 3, Appendix A), for unknown reasons. With no dissipation pool or stilling basin downstream, flows are concentrated through the notch. Excess energy and turbulence in this area and the left (south) bank have eroded approximately 10 feet of bank at the edge of the concrete apron. This has led to the failure of a private pedestrian crossing (Photo 3, Appendix A) and the undermining of the concrete apron (Photo 4, Appendix A). Additionally, the loss of the toe of the valley slope on the south bank has resulted in bank failures and large trees falling into and across the channel. The scour hole that formed at the outlet of the apron undermined the toe of the concrete bag retaining wall, (Photo 5, Appendix A), leading to the collapse of the wall in that section.
