Gungadin Drive Erosion Mitigation

Concept Design Report

Prepared for:
Anderson Township, Ohio

Prepared by:
Stantec
Cincinnati, Ohio

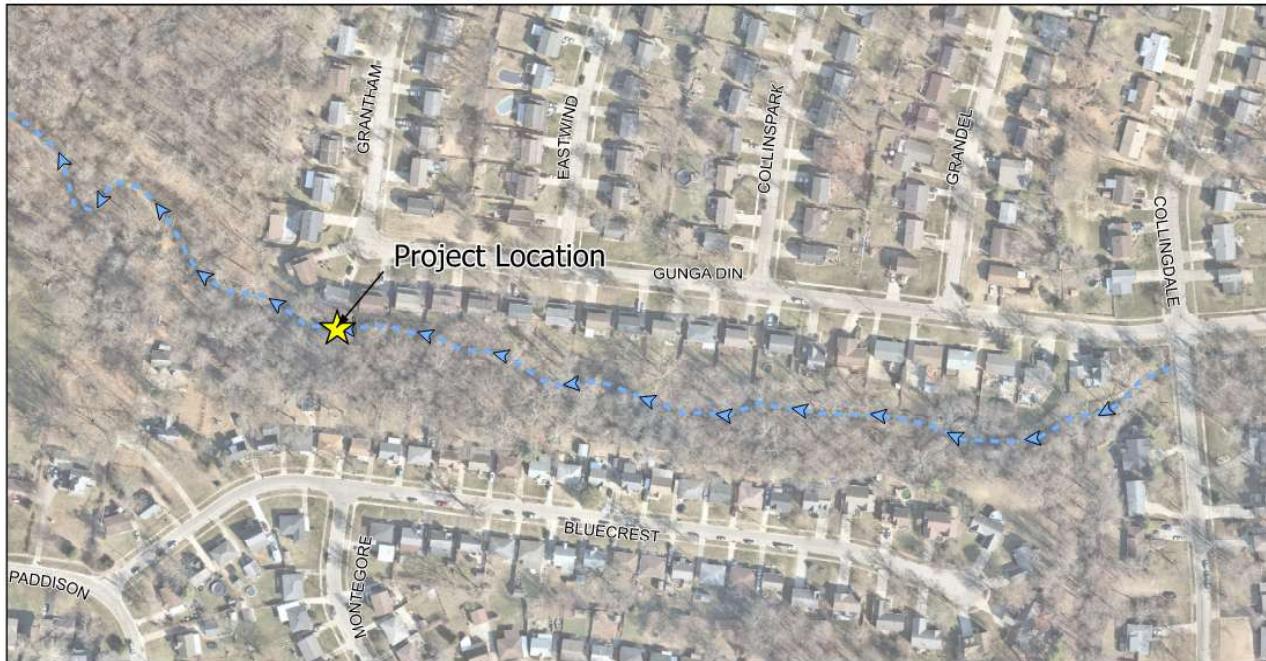
The project site is shown in Figure 1. An unknown tributary of Clough Creek flows east to west, generally parallel with Gungadin Drive. The primary focus area for this project is located near the west end of Gungadin Drive.

Figure 1. Project site overview
